# Interim Report

## **Monitoring and Evaluation of Thin Bonded Overlays and Surface Laminates for Bridge Decks**

**Montana Department of Transportation  
Research, Development, & Technology Transfer  
Program**

**August 1997**

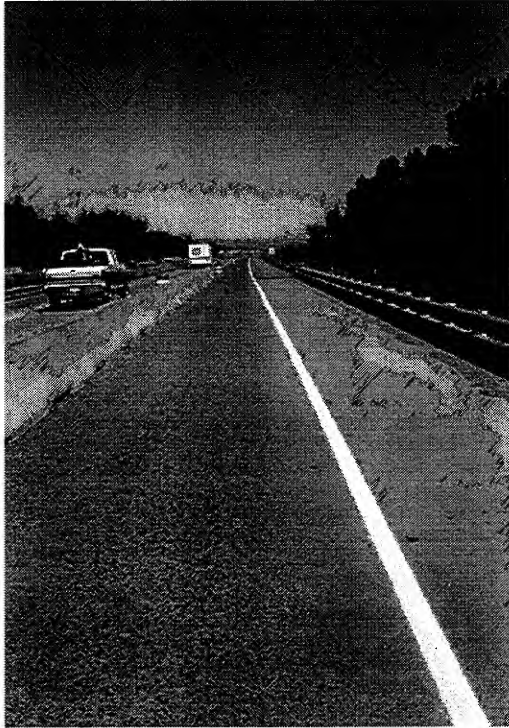
**Photo 1: Pre-installation, westbound Gallatin.**

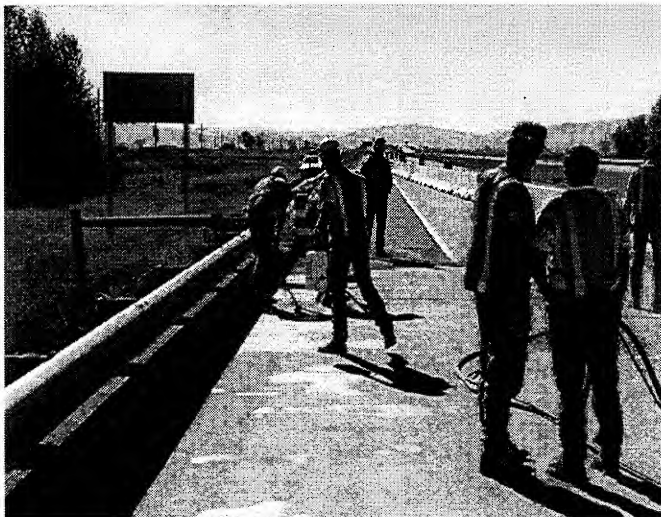
The Thorotop HCR material, consisting of the liquid Thoro polymer and Thoro HCR powder, was mixed on-site in continuous batches. These materials were typically mixed for approximately 5 minutes, sprayed onto the deck, and spread with squeegees (see Figure 3.1.1, Photo 3). Thorotop is placed in two lifts, with the first lift placed on a moist surface. A broom finish was applied to the first lift to promote bonding between the first and second lift. Note that the Thorotop polymer and powder were mixed on the deck, itself, in the area immediately preceding the point of application of the overlay. Polymer was occasionally spilled on the untreated deck during the mixing process as it was dispensed from its storage barrels.

**Photo 3: Thorotop HCR installation, Gallatin River.**

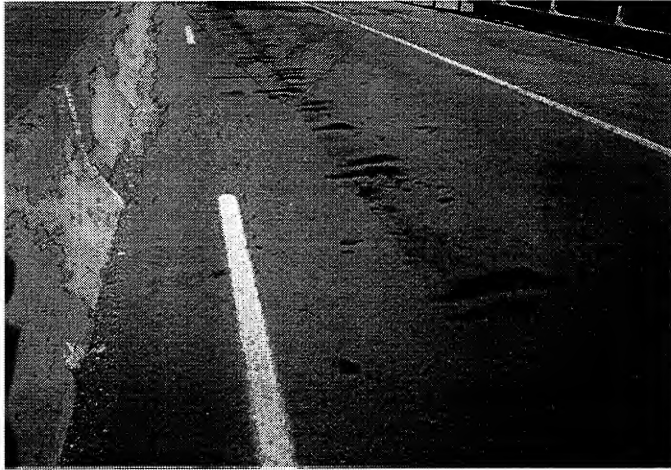
**Photo 5: Pre-installation, westbound West Garrison.**

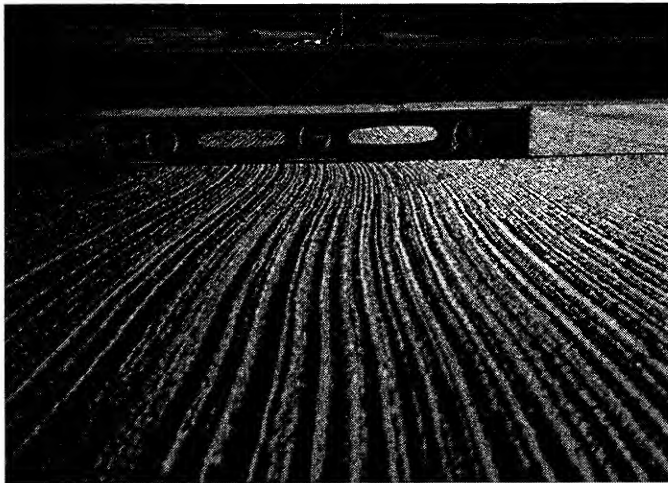
**Photo 7: Completed Thorotop HCR overlay, pre-traffic, West Garrison.**

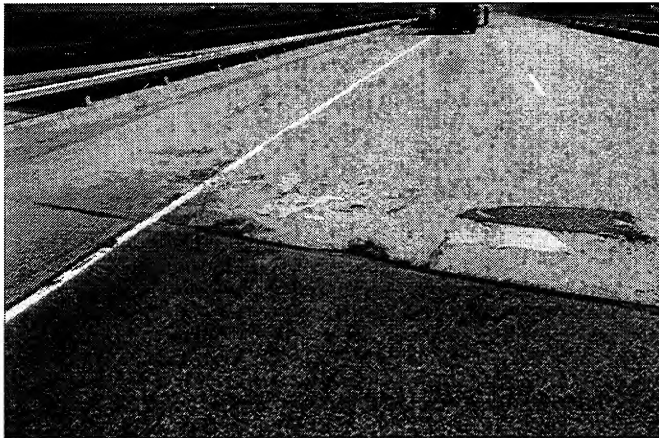
**Photo 8: Pre-installation, westbound Galen.**

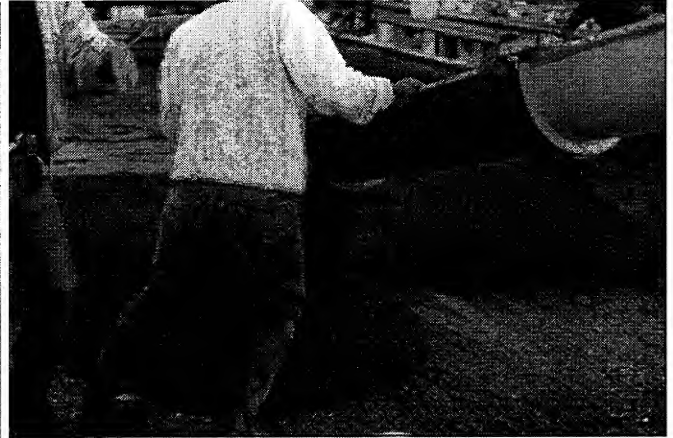
Following the preparation and repair of the decks and curing of repair areas, the overlay process began (see Figure 3.1.3, Photo 9). Application was made in a single lift. Both driving and passing lanes were completed at the same time. A power screed was utilized for the placement. Climatic conditions were measured by the MDT (see Appendix B). Traffic reintroduction occurred after a minimum of 6 days of curing.

**Photo 9: Silica fume installation, Galen.**

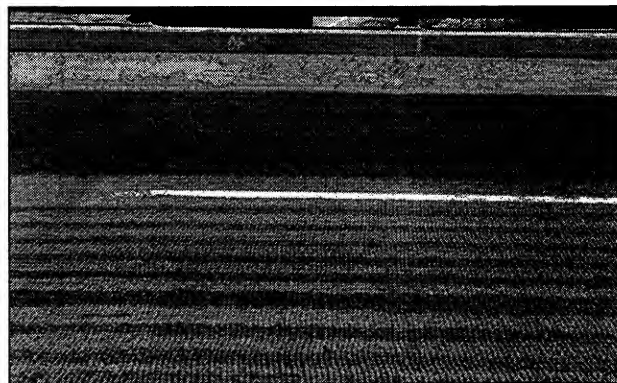
**Photo 10: Finished silica fume.**

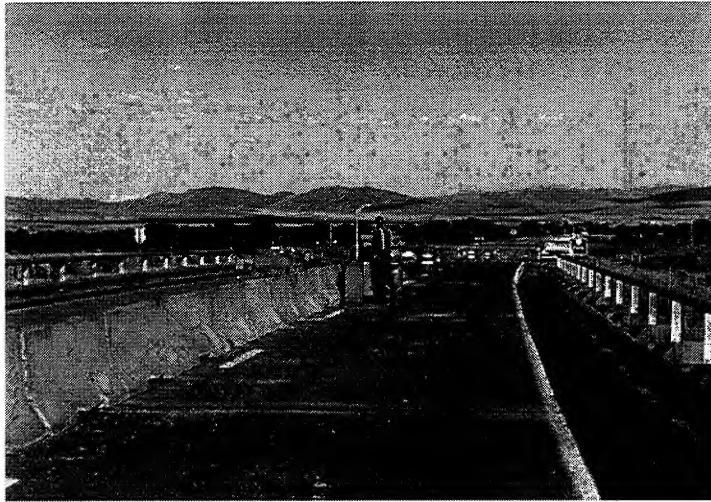
**Photo 11: Pre-installation, westbound Madison.**

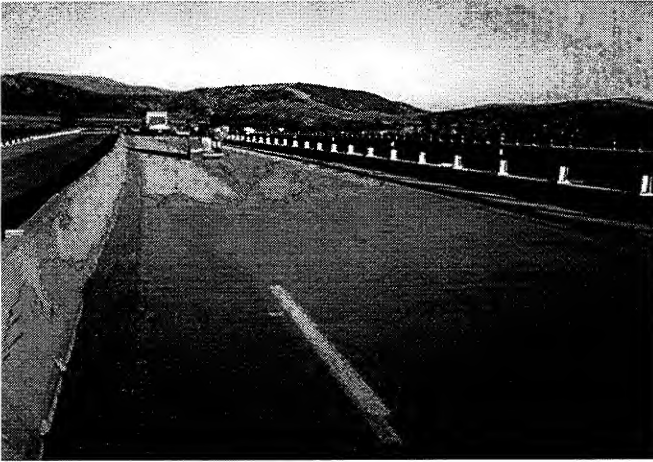
**Photo 14: Pre-installation, eastbound East Garrison**

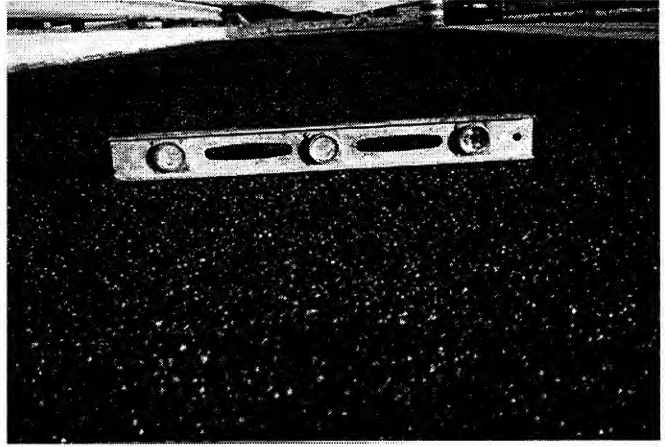
**Photo 19: Completed Degadur overlay, pre-traffic, Fairmont.**
